Petrographic Investigation of One Concrete Core Extracted from a Slab-on-Grade near the Moss Landing Harbor located in Moss Landing, California

Meredith Strow
Report No. 207527.d
9 October 2020

Appendix A	Moss Landing Slab Core A6-28 Petrography (ASTM C856)
Appendix B	Quantitative X-ray Diffraction (QXRD) Report
Appendix C	Scanning Electron Microscopy and Energy Dispersive X-ray Spectroscopy (SEM/EDS) (ASTM C1723)
Appendix D	Procedures

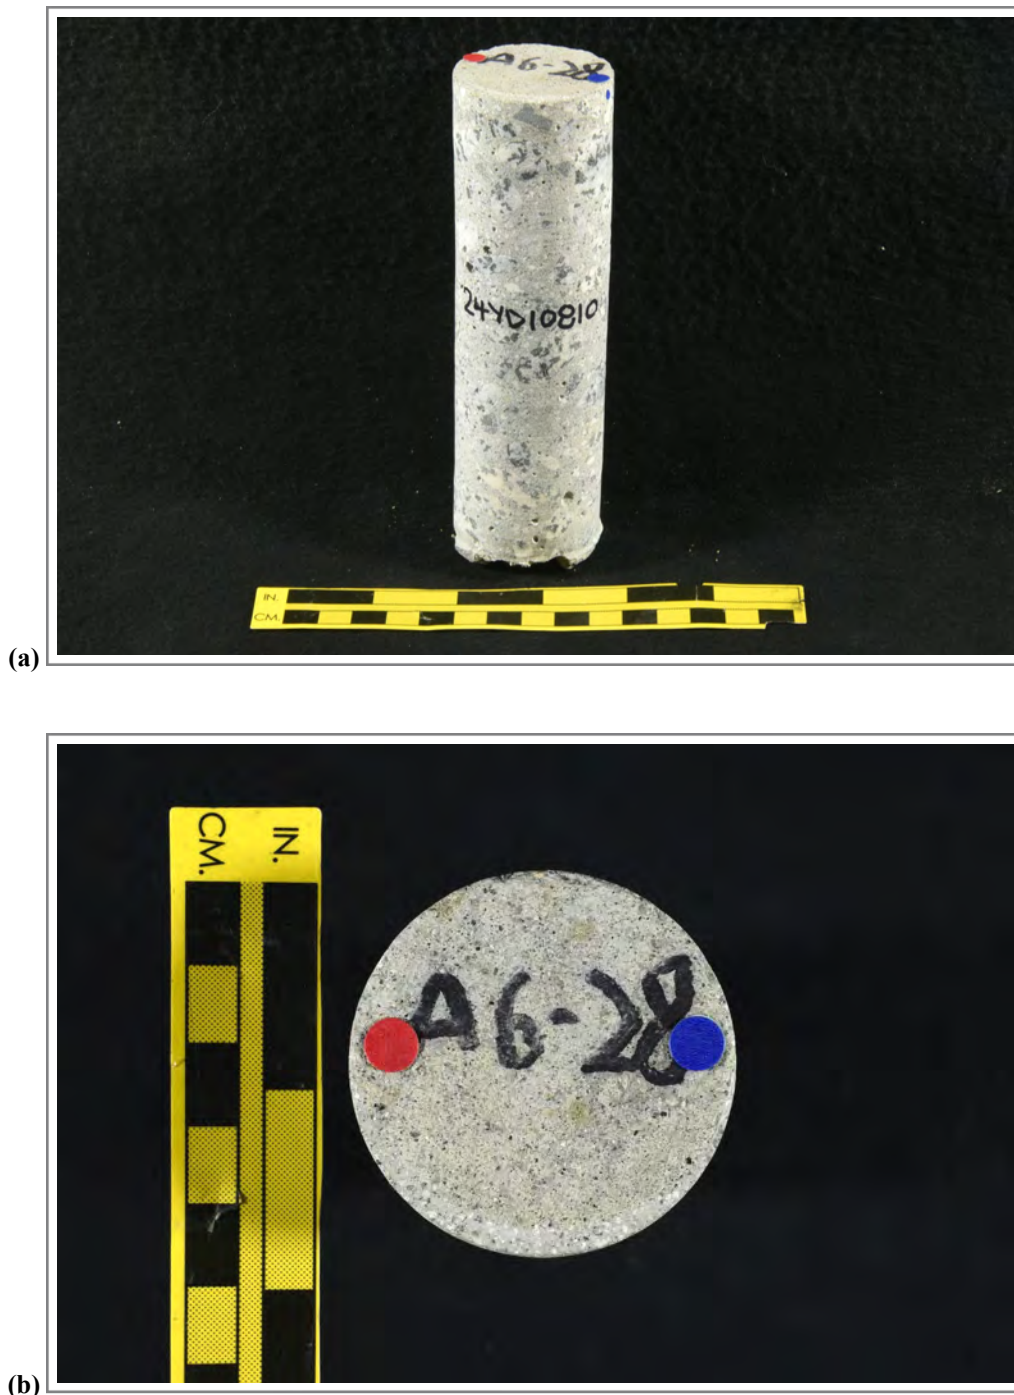
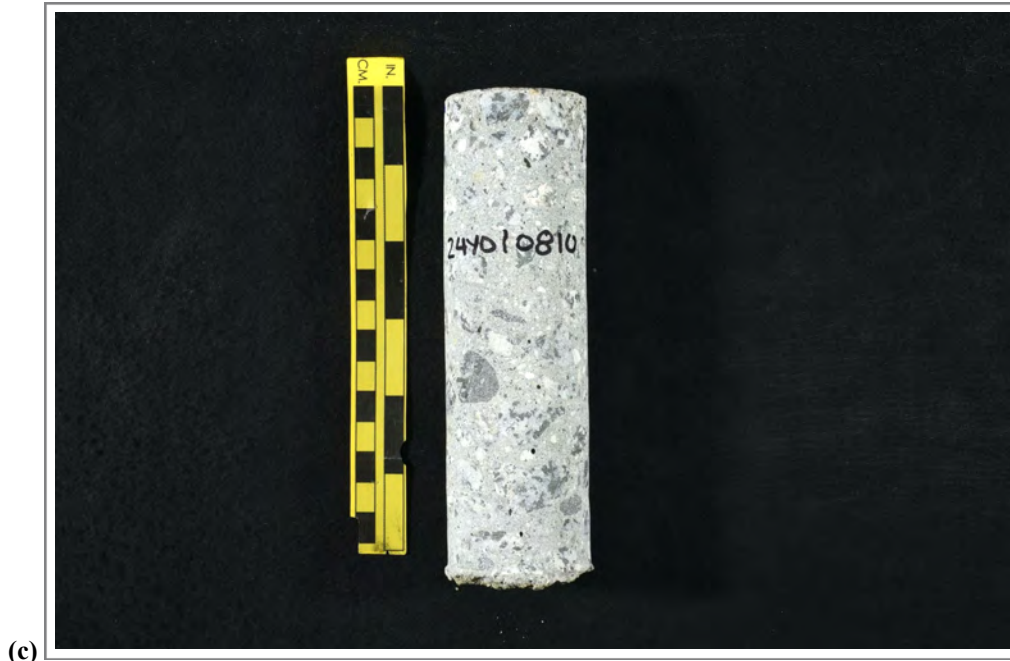
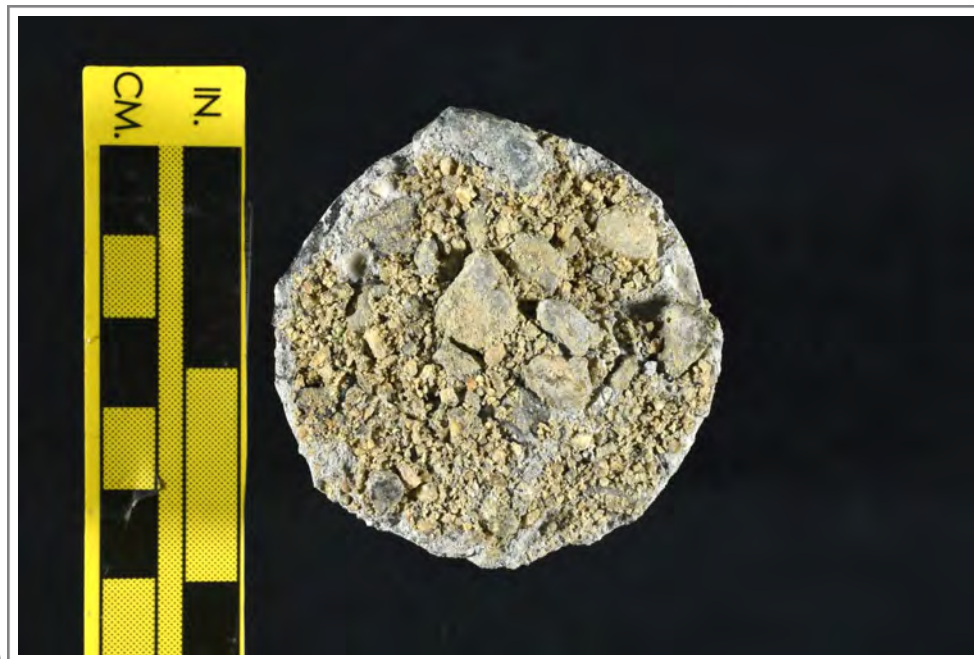
1. RECEIVED CONDITION	
ORIENTATION & DIMENSIONS	Sample is a vertical core measuring ~44 mm (1 3/4 in.) in diameter and ~152 mm (6 in.) in length (Figure A1).
SURFACES	The top surface is a flat, worn concrete surface with fine aggregate is exposed in low relief; no surface finish is observed. The bottom surface is a rough, uneven concrete surface with adhered gravelly sub-base such that the core represents a full thickness of the slab. (see Figure A1)
GENERAL CONDITION	The core was received hard and intact in one piece (Figures A1 and A2).

Figure A1. Photographs of the core in as-received condition showing (a) an oblique view of the top surface and side of the core with identification labels and (b) the top surface of the core. The red and blue dots show the orientation of the saw cuts used to prepare the core. The yellow scale is ~ 150 mm (6 in.) long; the small and large divisions are in centimeters and inches, respectively.

Figure A1 (cont'd). Photographs of the core in as-received condition showing (c) the side of the core and (d) the bottom surface of the core. The yellow scale is ~ 150 mm (6 in.) long; the small and large divisions are in centimeters and inches, respectively.

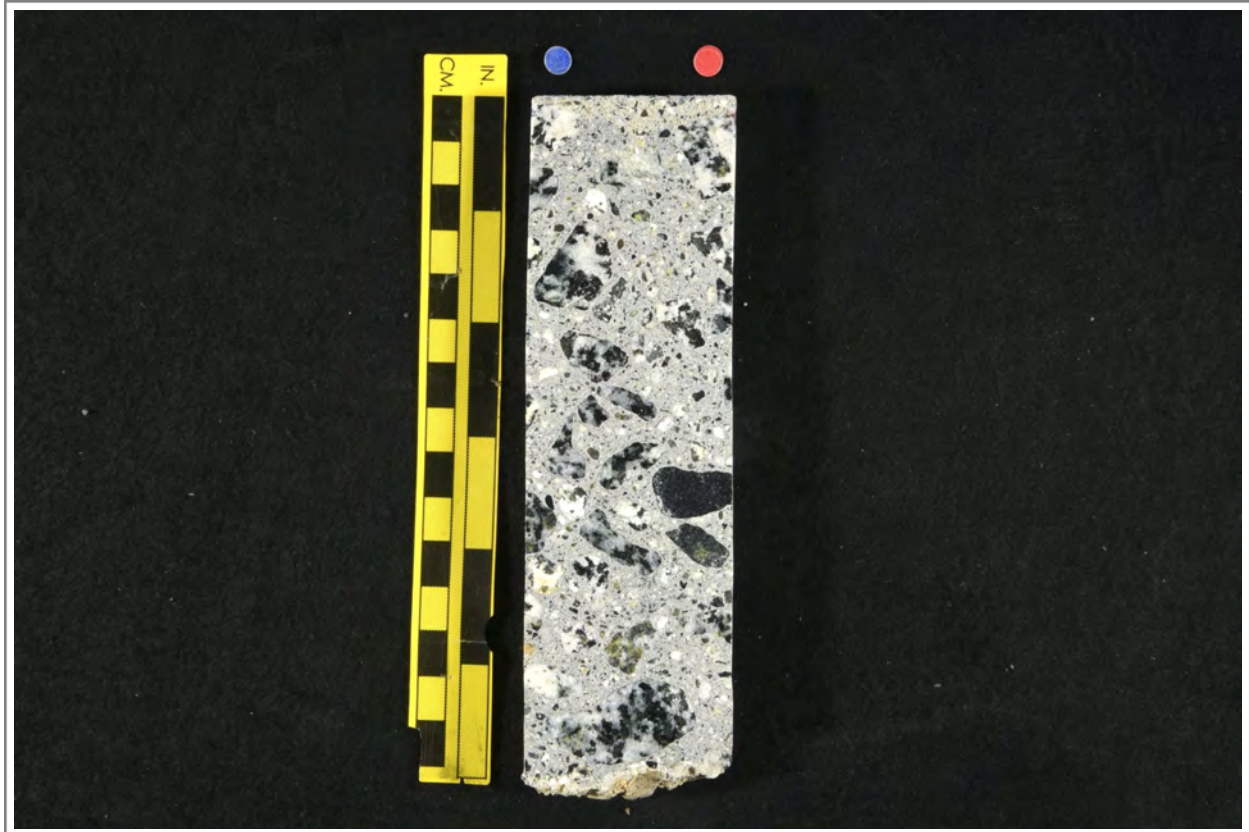
Figure A2. Photograph showing the polished surface of the core. The small and large divisions on the yellow scale are in centimeters and inches, respectively.

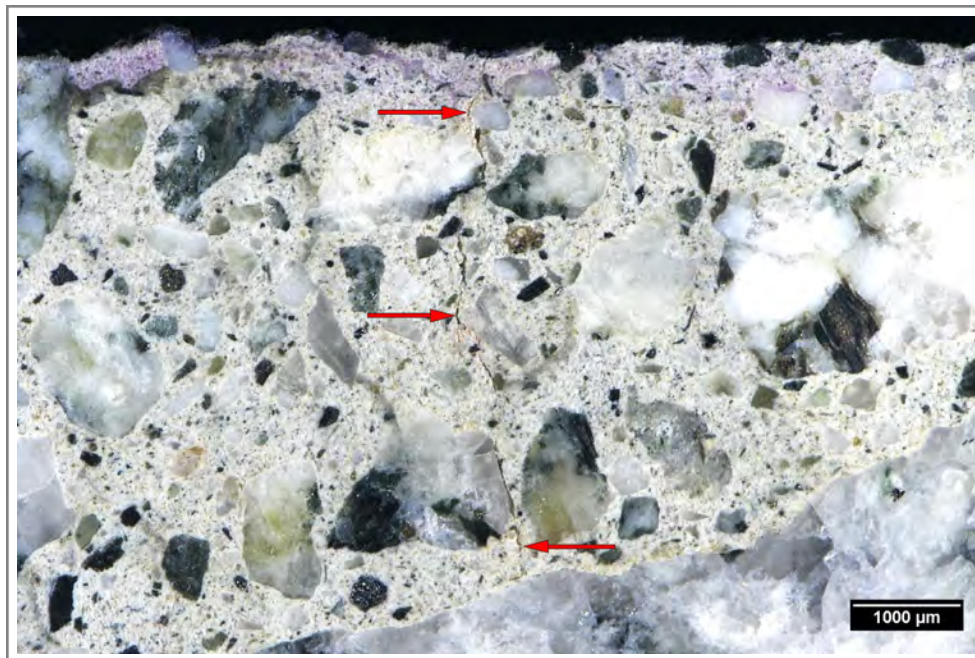
3. CRACKING	
MACROSCOPIC	None present.
MICROSCOPIC	A couple vertical 50-75 μm (2-3 mil) wide microcracks extend down from the top surface to depths of 5 to 12 mm (1/8 - 1/2 in.) into the core (Figure A3). Only few randomly-oriented 25-50 μm (1-2 mil) wide microcracks are observed within the paste in thin section.

Figure A3. Reflected light photomicrograph showing vertical microcrack (red arrows) in top portion of core.

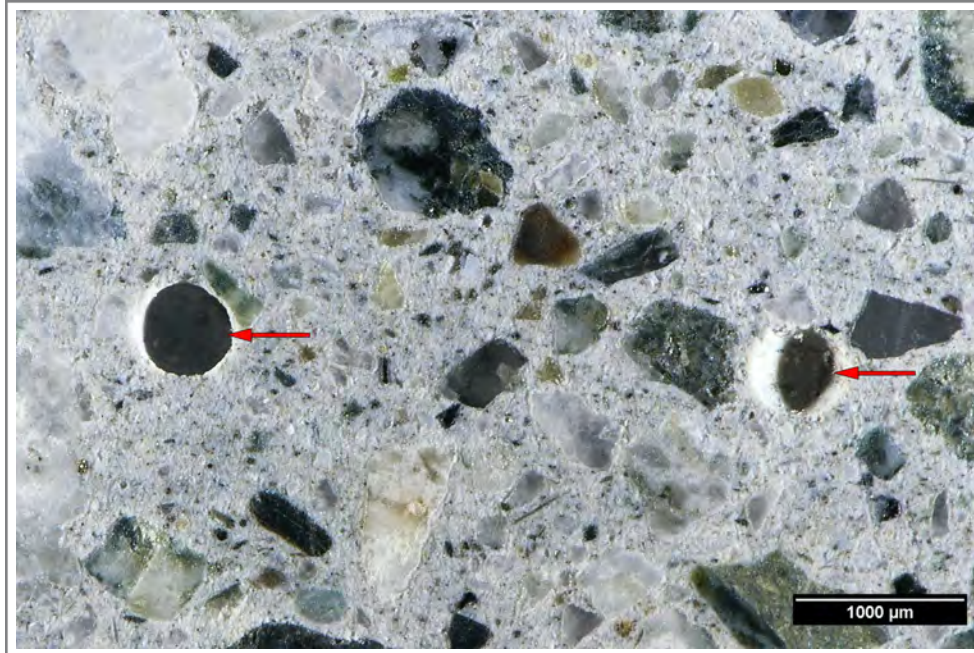
4. VOIDS	
VOID SYSTEM	The concrete is non-air-entrained; total air content is estimated at less than 3%. Few spherical voids are observed throughout the core (Figure A4). The concrete is well consolidated with no notable entrapped voids in the body of the core.
VOID FILLINGS	None present, as observed on the polished surface of the core.

Figure A4. Reflected light photomicrograph showing numerous air voids (red arrows) throughout the paste.

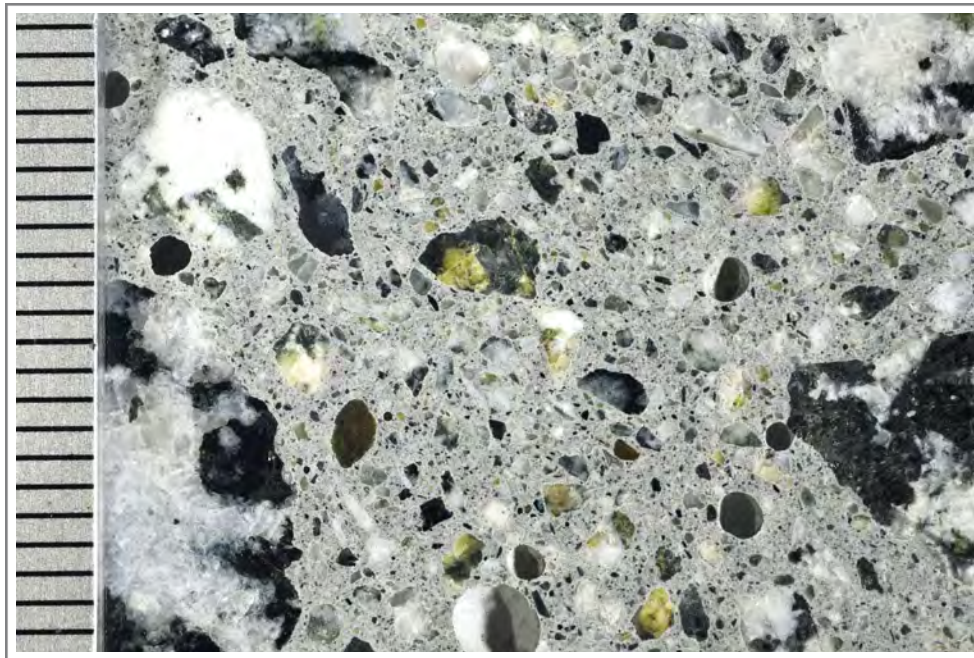
5. COARSE AGGREGATE	
PHYSICAL PROPERTIES	The coarse aggregate is a crushed quarried stone with a 12.5 mm (1/2 in.) nominal top size. Particles are hard and dense, well graded, equant in shape, angular to sub-angular in texture, and uniformly distributed throughout the core (Figure A5).
ROCK TYPES	The coarse aggregate is siliceous in composition. The aggregate consists predominantly of granodiorite with few gabbro particles and metamorphic rocks. No particles are potentially susceptible to alkali-silica reaction (ASR). No carbonate particles are observed; no particles are potentially susceptible to alkali-carbonate reaction (ACR).
OTHER FEATURES	No evidence of ASR or ACR is observed. No coatings are observed.

Figure A5. Photograph of the polished surface showing detail of the coarse aggregate. Scale is in millimeters.

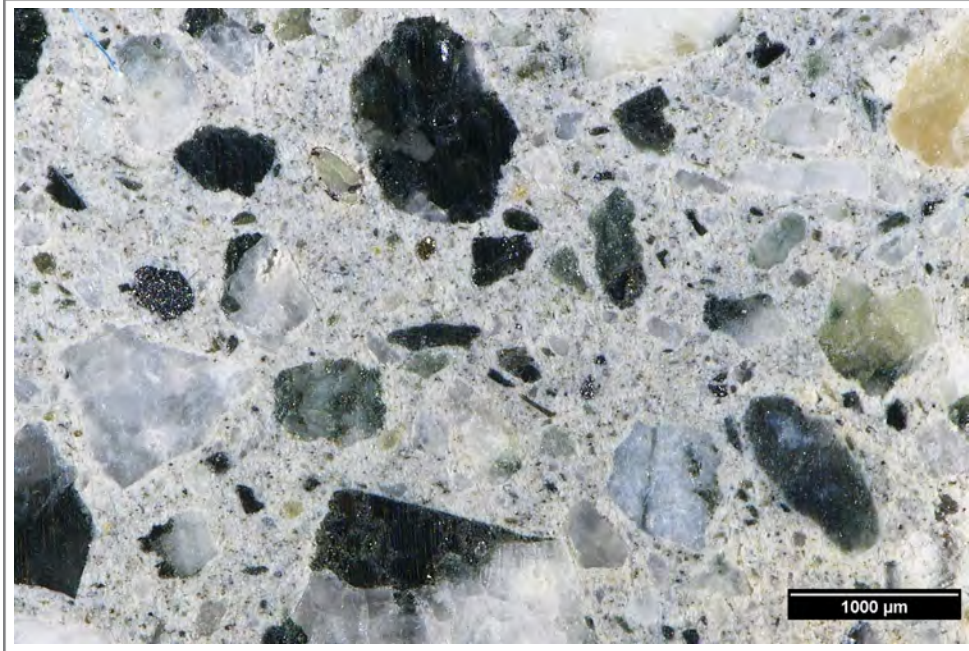
6. FINE AGGREGATE	
PHYSICAL PROPERTIES	The fine aggregate is a natural sand. Particles are hard and dense, equant to elongated in shape, angular to sub-angular in texture, and uniformly distributed throughout the core (Figure A6).
ROCK TYPES	The fine aggregate consists predominantly of feldspar, quartz, pyroxene, amphibole, granite, quartzite, chert, biotite, chlorite and few other rock and mineral particles. Quartzite and chert are potentially susceptible to alkali-silica reaction (ASR). No carbonate particles are observed; no particles are potentially susceptible to alkali-carbonate reaction (ACR).
OTHER FEATURES	No evidence of ASR or ACR is observed. No coatings are observed.

Figure A6. Reflected light photomicrograph of the polished surface showing the fine aggregate.

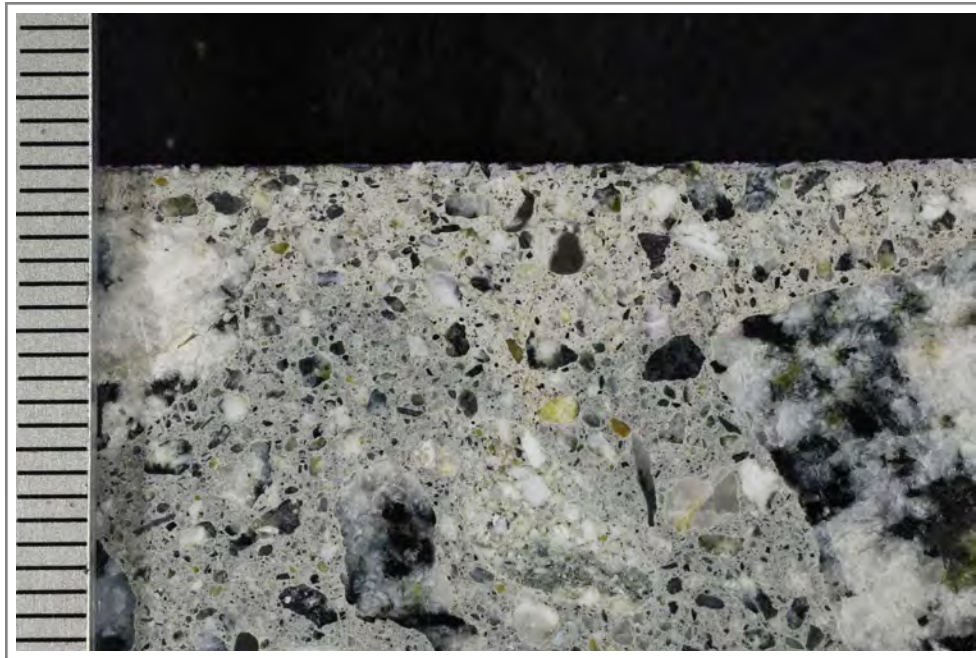
Figure A7. Photograph showing detail of the paste on the polished surface in the top portion of the core. Scale is in millimeters.

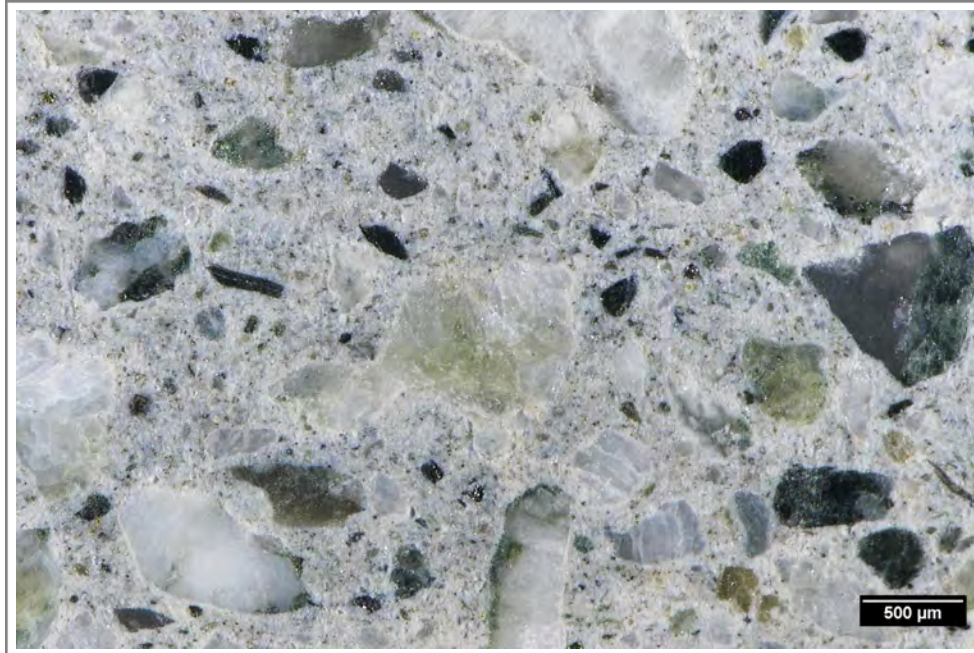
Figure A8. Reflected light photomicrograph showing detail of the paste in the body of the core on the polished surface.

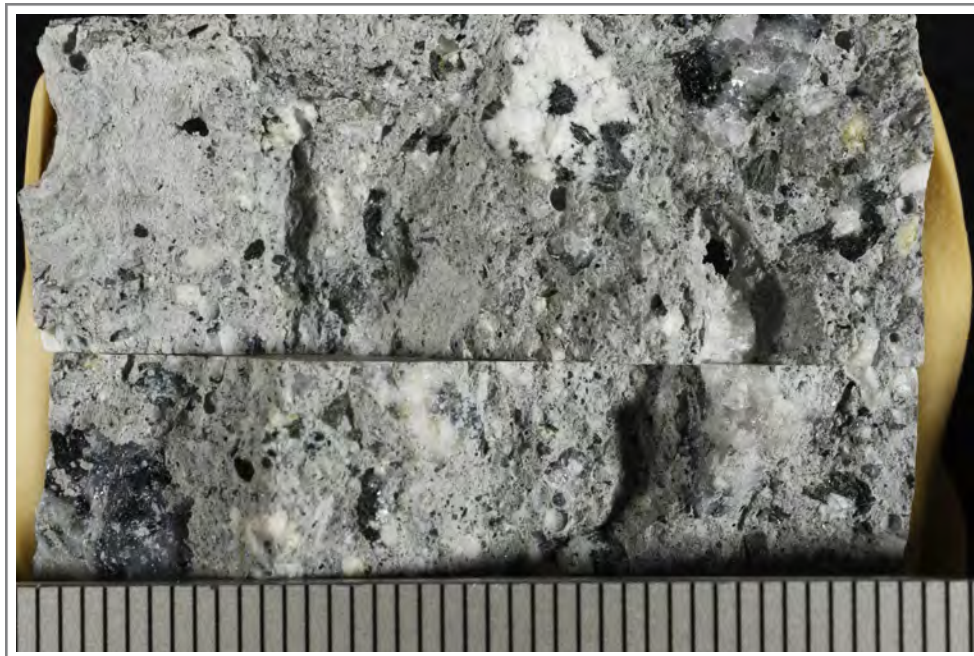
Figure A9. Photograph showing detail of the paste on freshly fractured surfaces. Scale is in millimeters.

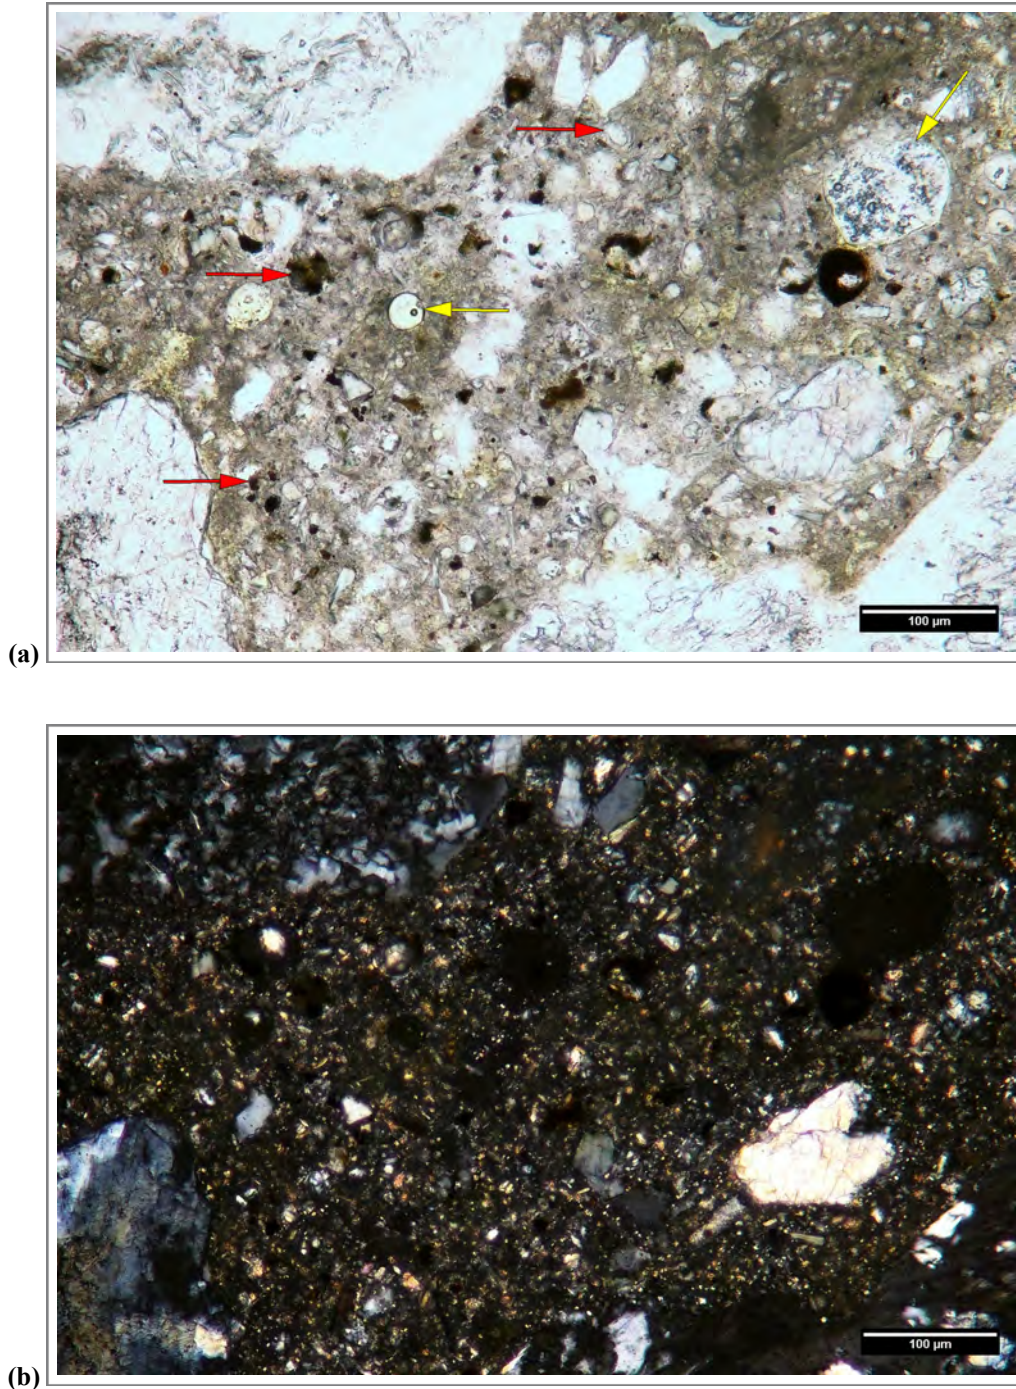
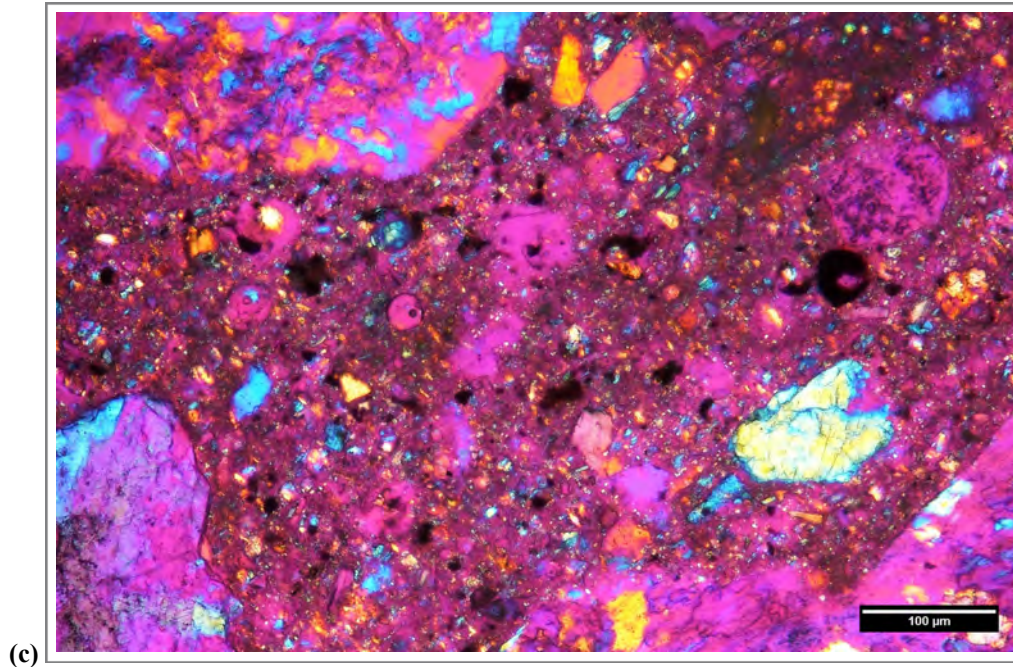
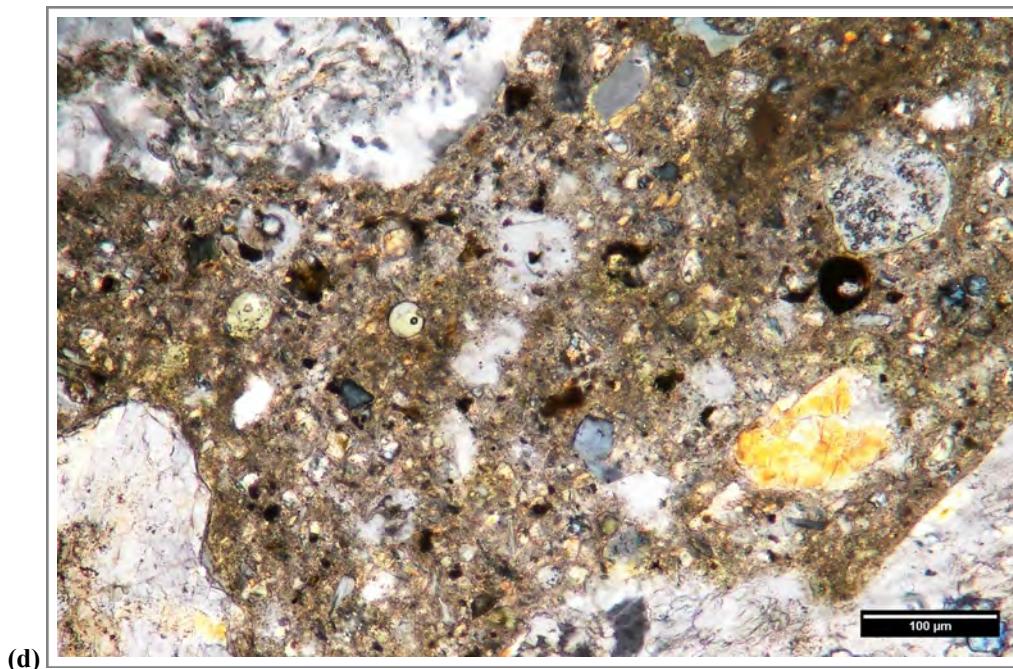
Figure A10. Transmitted light photomicrographs of thin section showing detail of paste in (a) plane-polarized and (b) cross-polarized light. Red arrows indicate portland cement particles and yellow arrows indicate fly ash particles in (a).

Figure A10 (cont'd). Transmitted light photomicrographs of thin section showing detail of paste in (c) cross-polarized light with the gypsum plate inserted and (d) cross-polarized light with the quarter wavelength plate inserted.

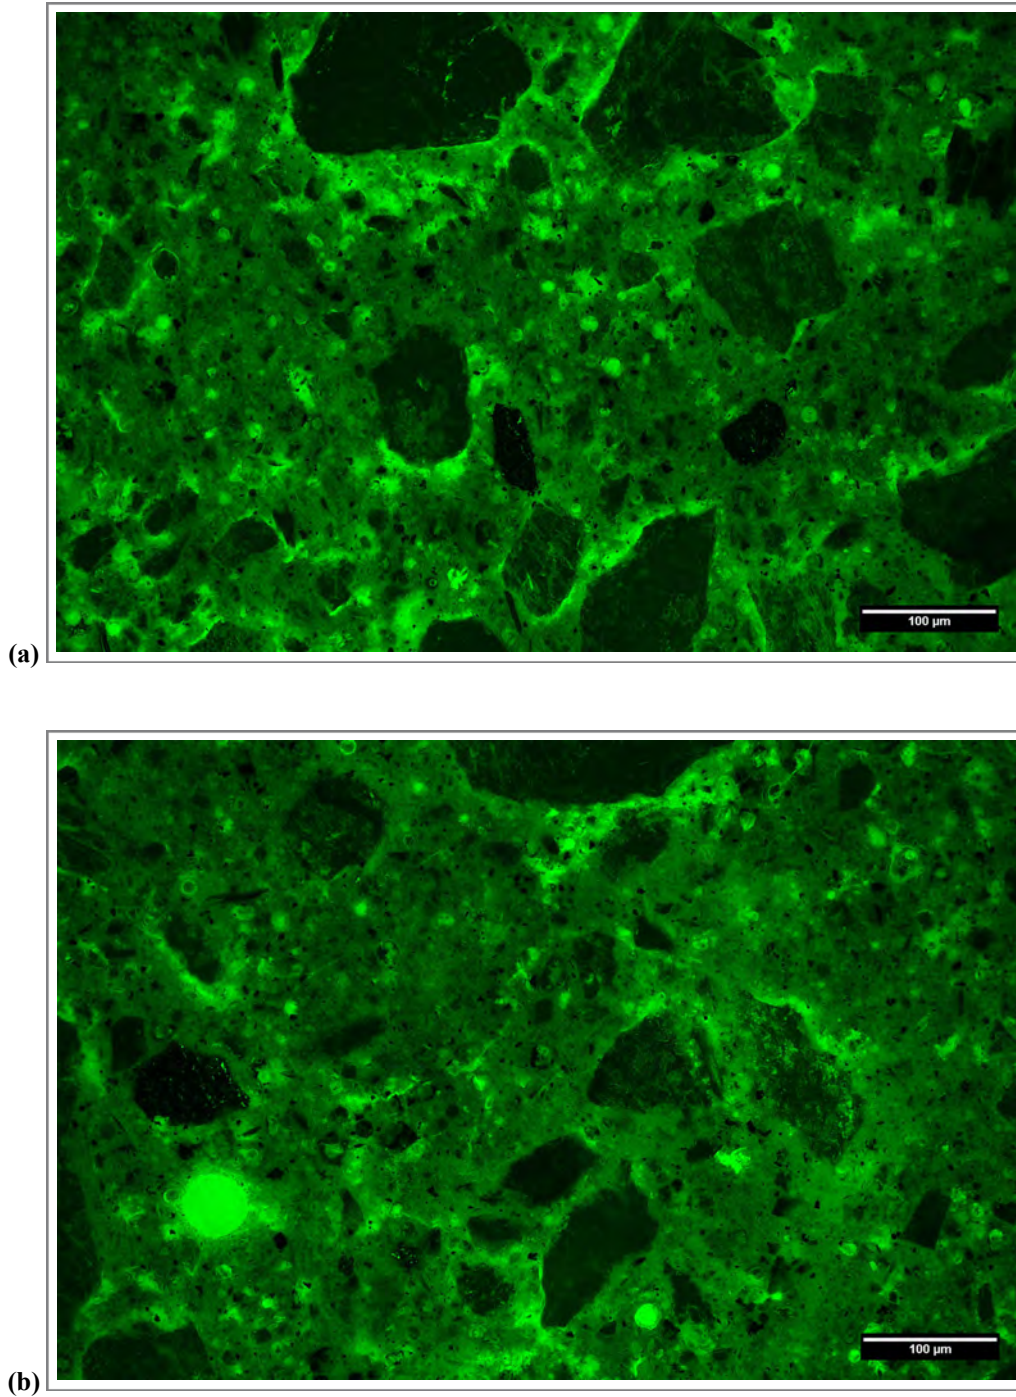
ESTIMATED W/CM	The paste exhibits moderately low capillary porosity and the w/cm is estimated at 0.40 ± 0.05 (Figure A11).

Figure A11. Transmitted light photomicrographs of thin section showing detail of paste in fluorescent light in two different regions of the core. The bright circular areas are voids that have 100% porosity and the black regions are aggregate particles with effectively zero porosity. The variations in green tone between these two end-members reflect variations in the capillary porosity of the paste.

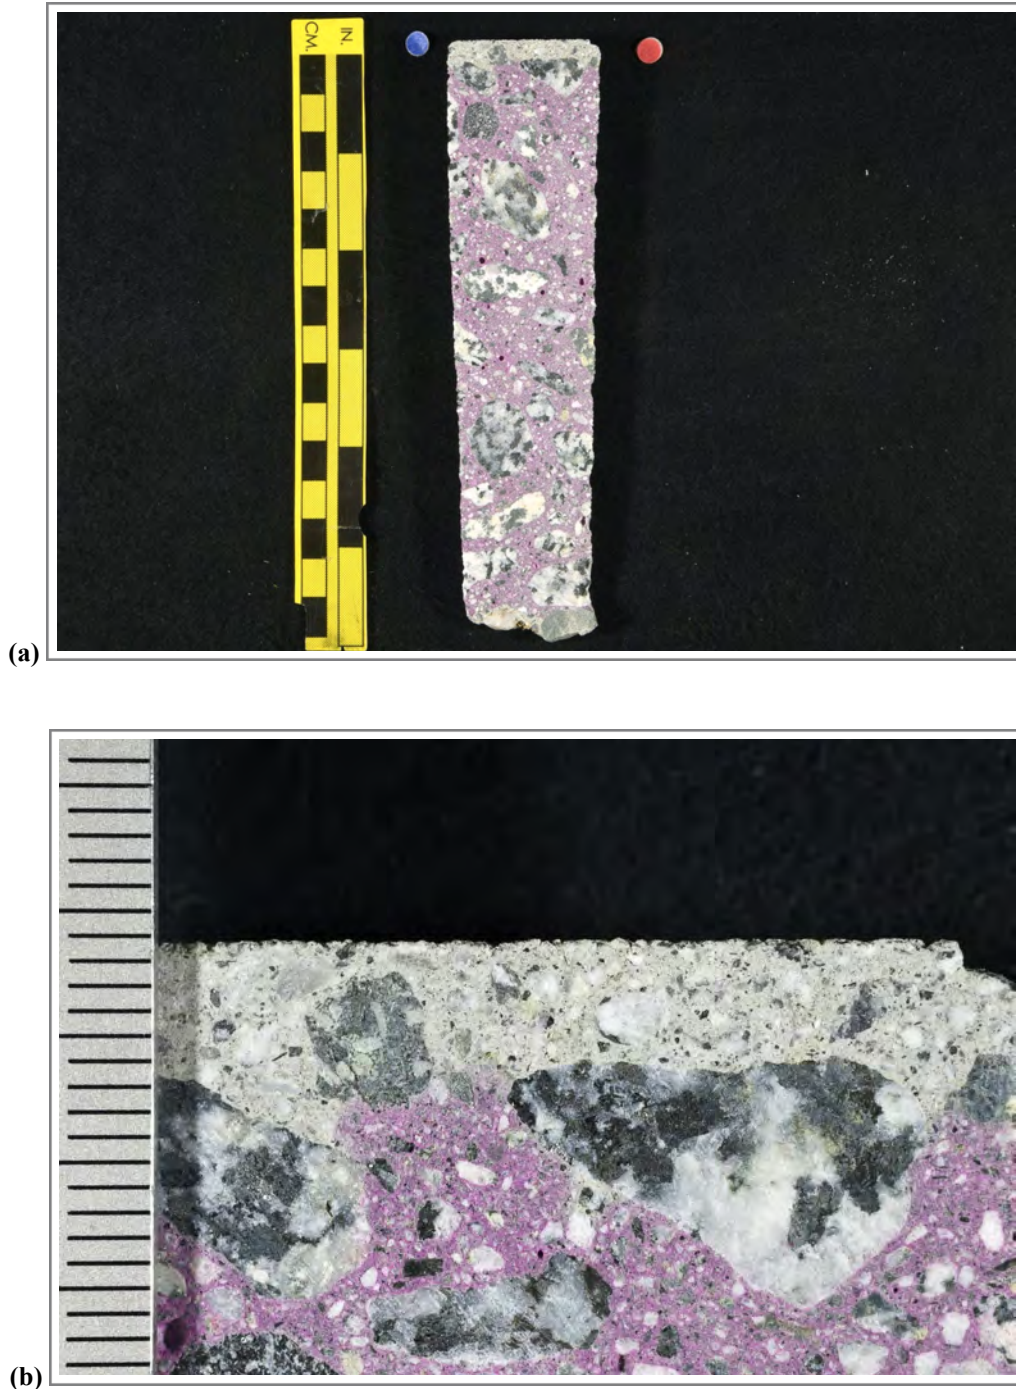
8. SECONDARY DEPOSITS	
PHENOLPHTHALEIN	After phenolphthalein was applied to a cross-sectional saw-cut surface of the core, the paste throughout the core stained dark purple except for the top 4-6 mm (1/8-1/4 in.). (Figure A12); this testing is performed to determine general depth of paste carbonation.
SECONDARY DEPOSITS	Other than carbonation, no additional secondary deposits are observed.

Figure A12. Photographs showing (a) overview of phenolphthalein-stained cross-sectional surface of the core, and (b) detail of stained surface at the top of the core. The yellow scale in (a) is ~150 mm (6 in.) long; the small and large divisions are in centimeters and inches, respectively. The scale in (b) is in millimeters.

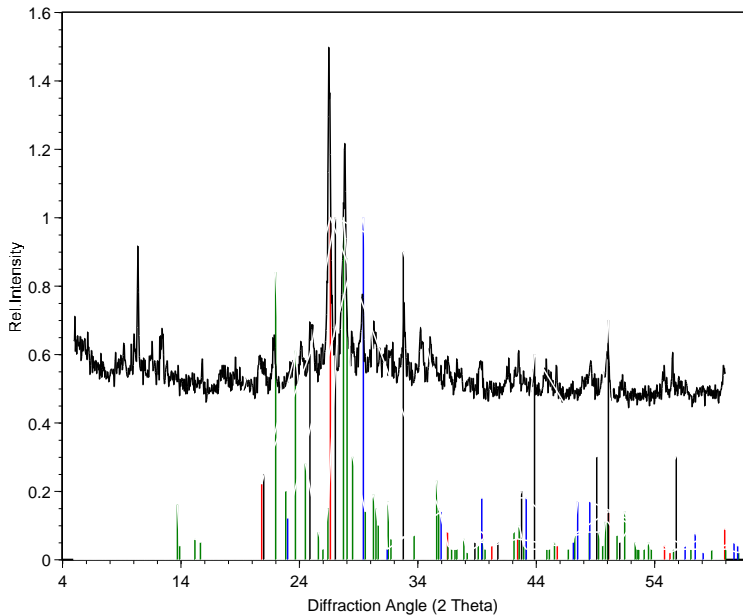
XRD patterns are shown in the attached Figures 1 and 2. Stick patterns for reference mineral standards from the Powder Diffraction File (PDF) database are also shown. Rietveld plot is shown in Figure 3

Figure 1: XRD pattern for the **concrete sample** with stick patterns for reference phases: **quartz (red)**, **feldspars (green)**, **calcite (blue)**, and **vaterite (black)**

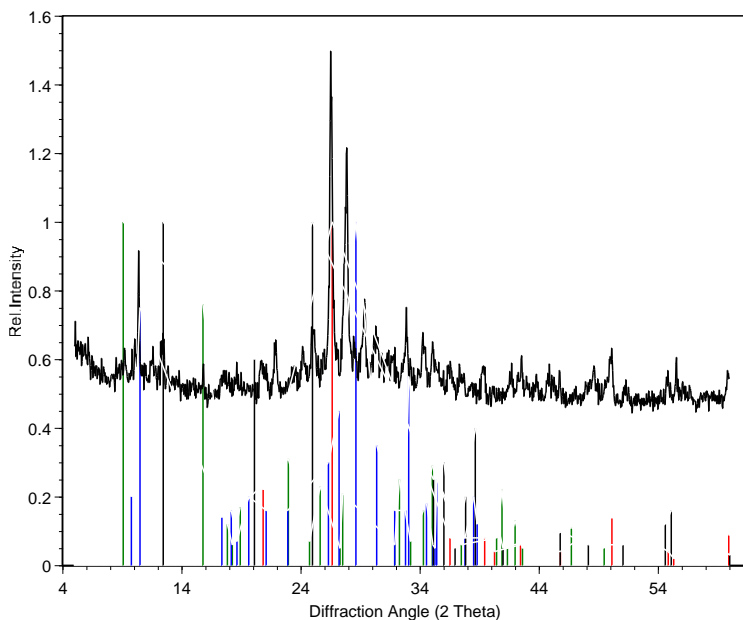
Figure 2: XRD pattern for the **concrete sample** with stick patterns for reference phases: **quartz (red)**, **ettringite (green)**, **actinolite (blue)**, and **kaolinite (black)**

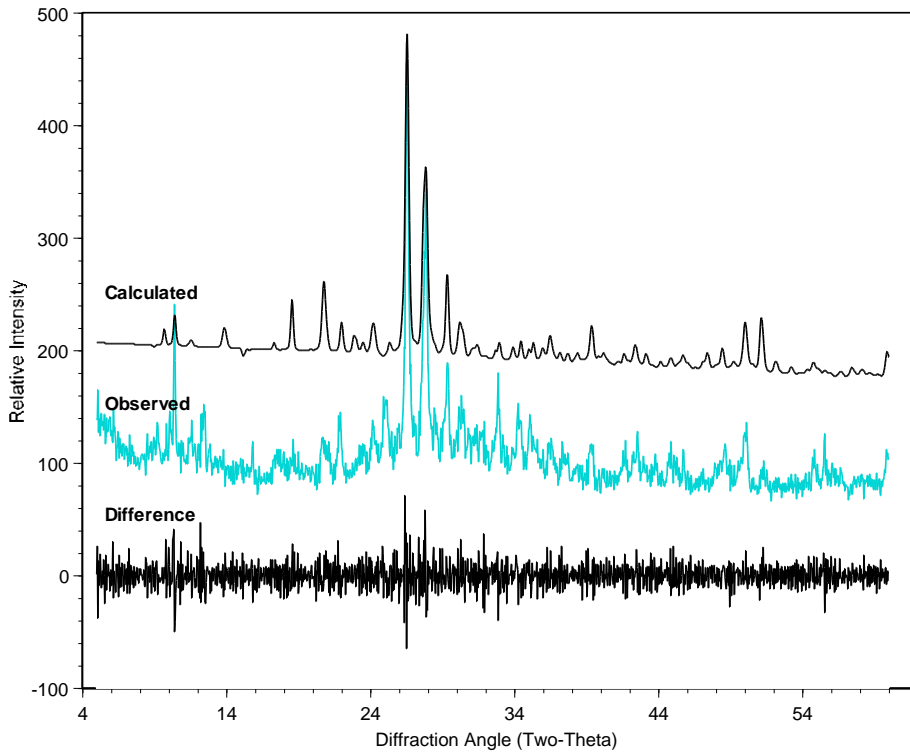
Fig 3: Calculated and observed XRD patterns for **the concrete sample**

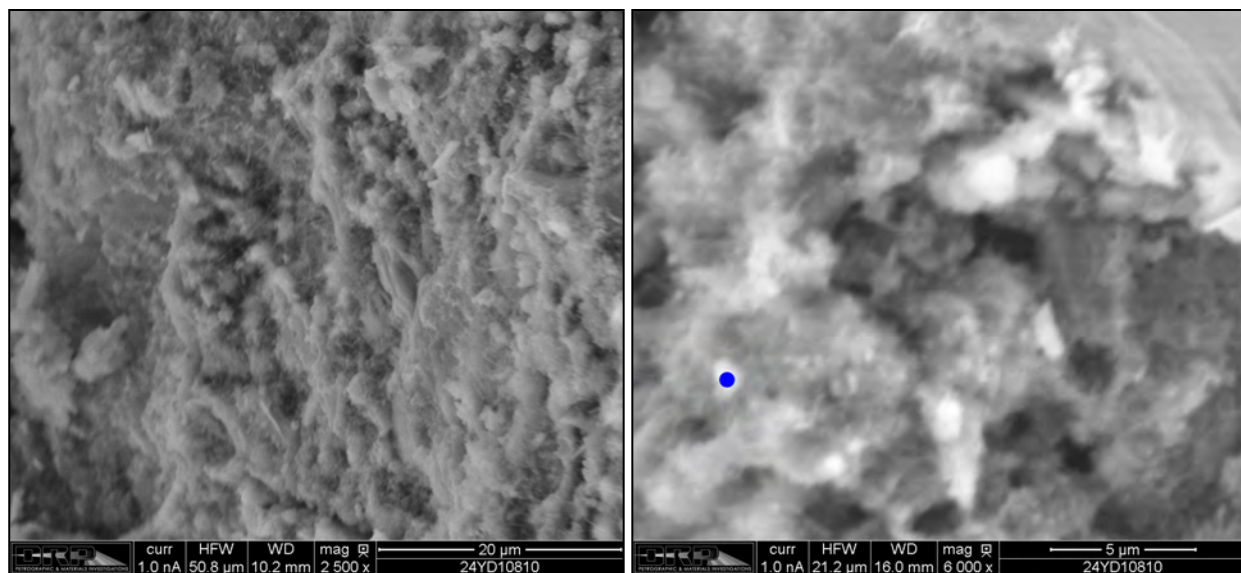
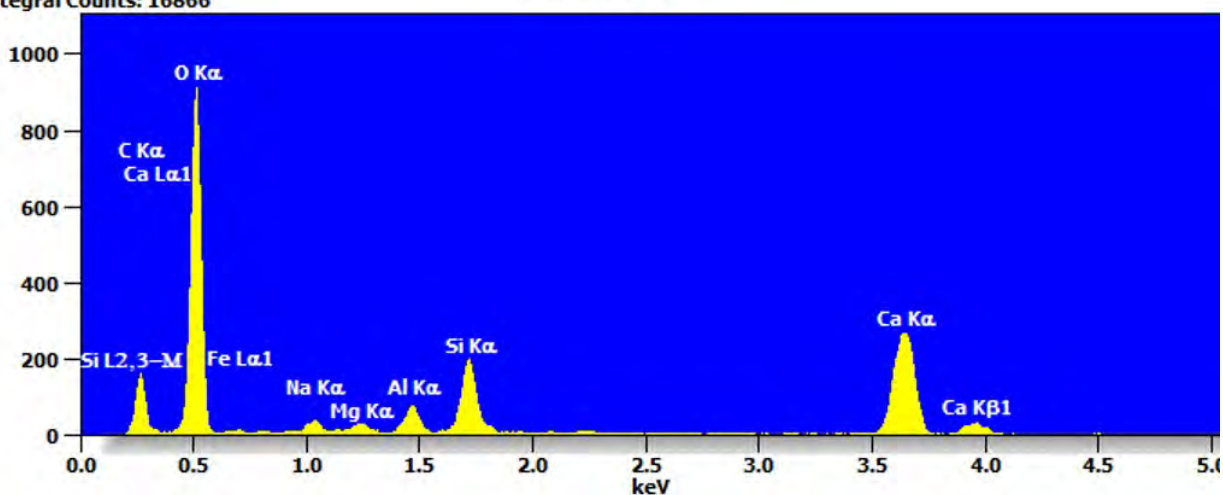
Figure C1. (a) Secondary electron micrograph of a fractured concrete surface at 2500x magnification. (b) Secondary electron micrograph of the same region of fractured surface shown in (a) at 6000x magnification with EDS point analysis location indicated by blue circle. (c) Corresponding spectrum from EDS point analysis shown in (b). Note carbon K α peak at ~0.3 keV, oxygen K α peak at ~0.5 keV, and calcium K α peak at ~3.7 keV.

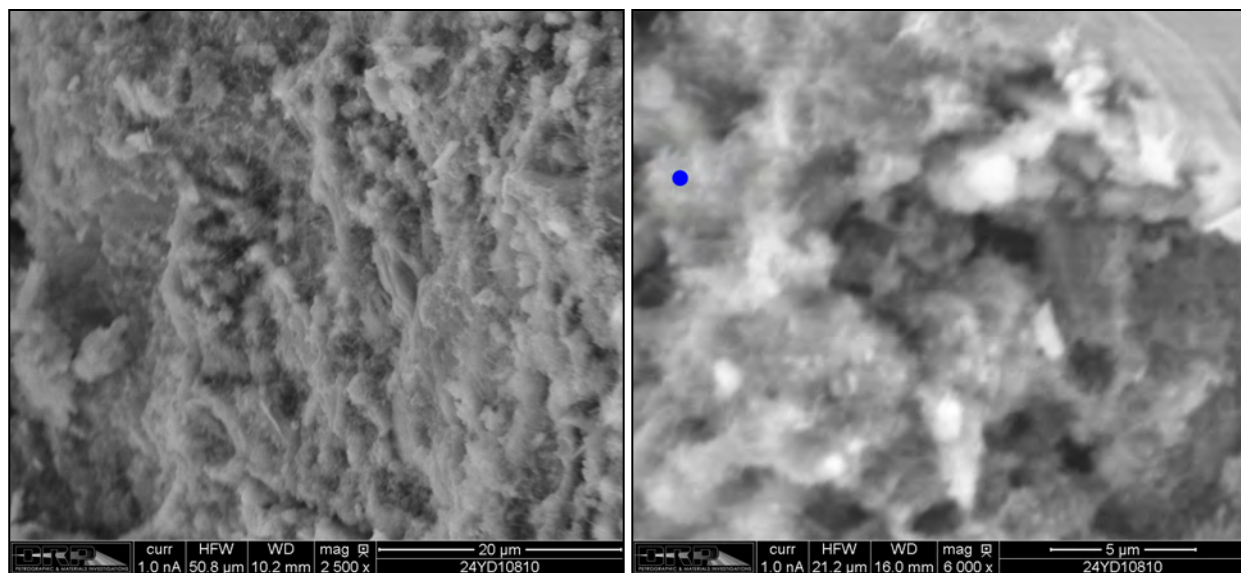
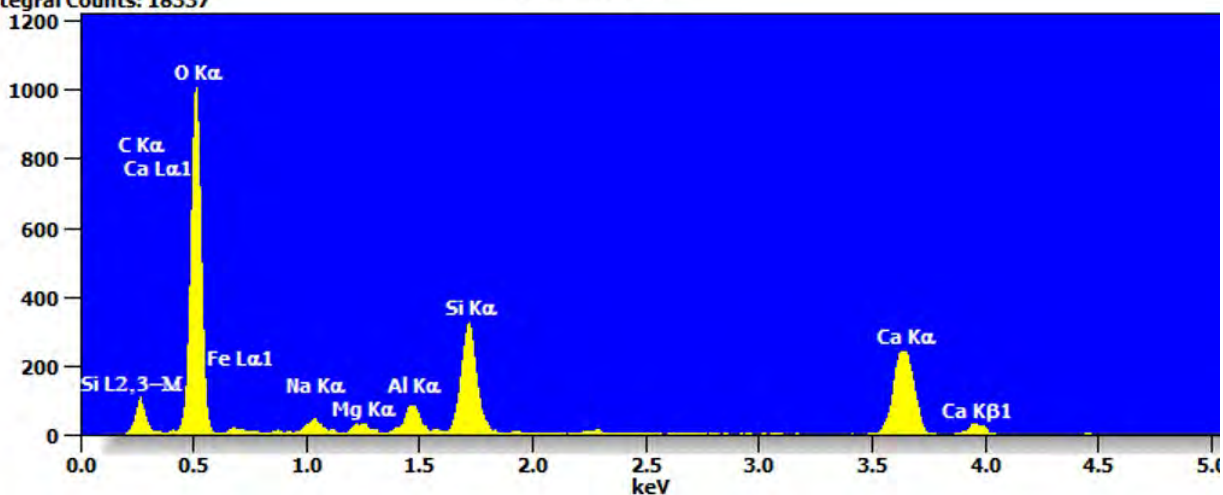
Figure C2. (a) Secondary electron micrograph of a fractured concrete surface at 2500x magnification. (b) Secondary electron micrograph of the same region of fractured surface shown in (a) at 6000x magnification with EDS point analysis location indicated by blue circle. (c) Corresponding spectrum from EDS point analysis shown in (b). Note carbon K α peak at ~0.3 keV, oxygen K α peak at ~0.5 keV, and calcium K α peak at ~3.7 keV.

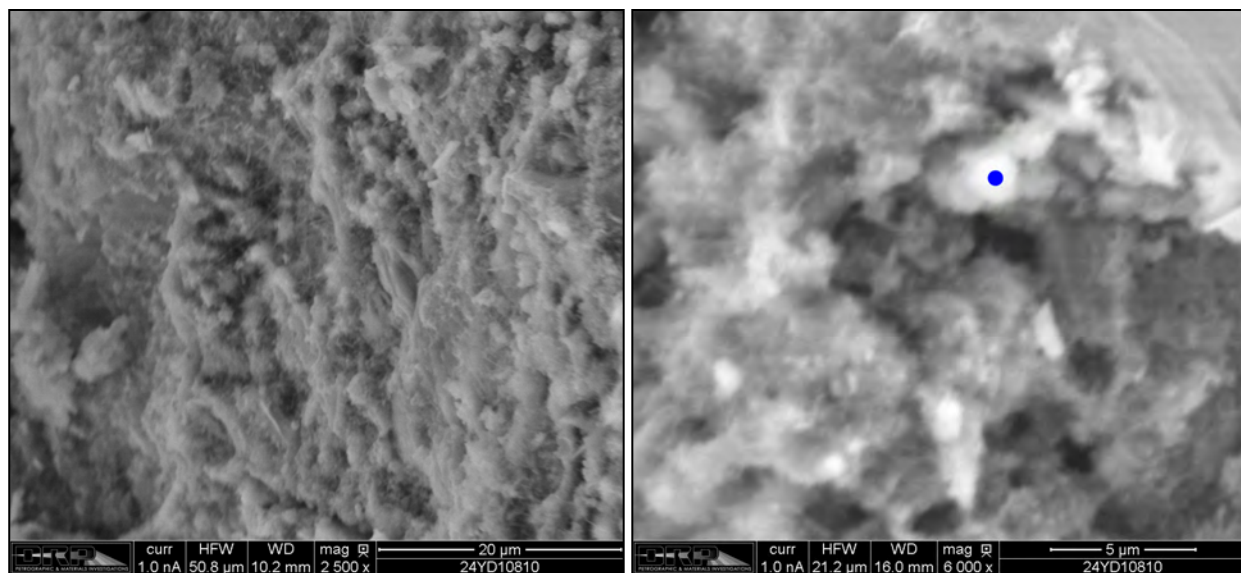
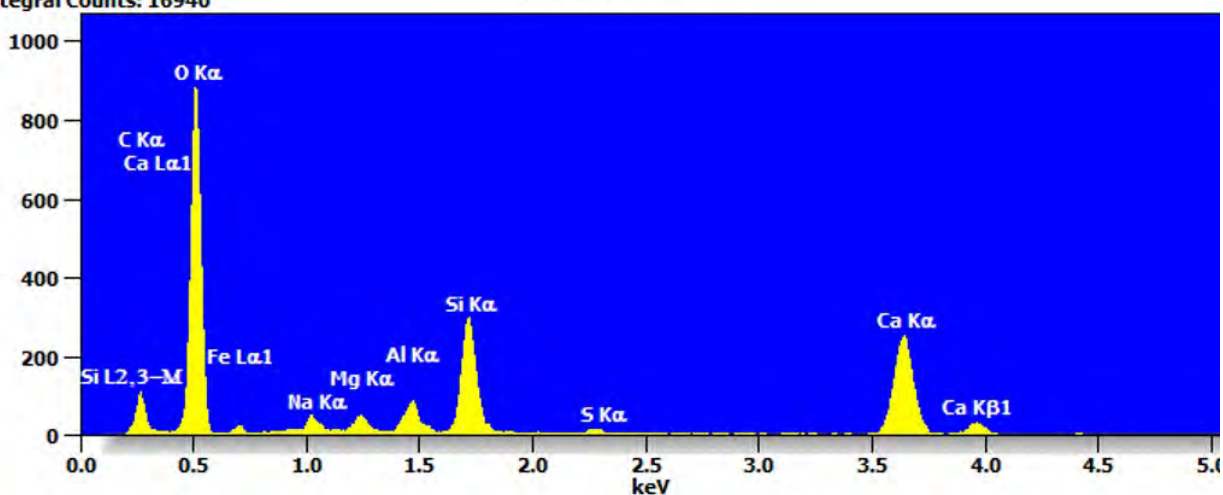
Figure C3. (a) Secondary electron micrograph of a fractured concrete surface at 2500x magnification. (b) Secondary electron micrograph of the same region of fractured surface shown in (a) at 6000x magnification with EDS point analysis location indicated by blue circle. (c) Corresponding spectrum from EDS point analysis shown in (b). Note carbon K α peak at ~0.3 keV, oxygen K α peak at ~0.5 keV, and calcium K α peak at ~3.7 keV.

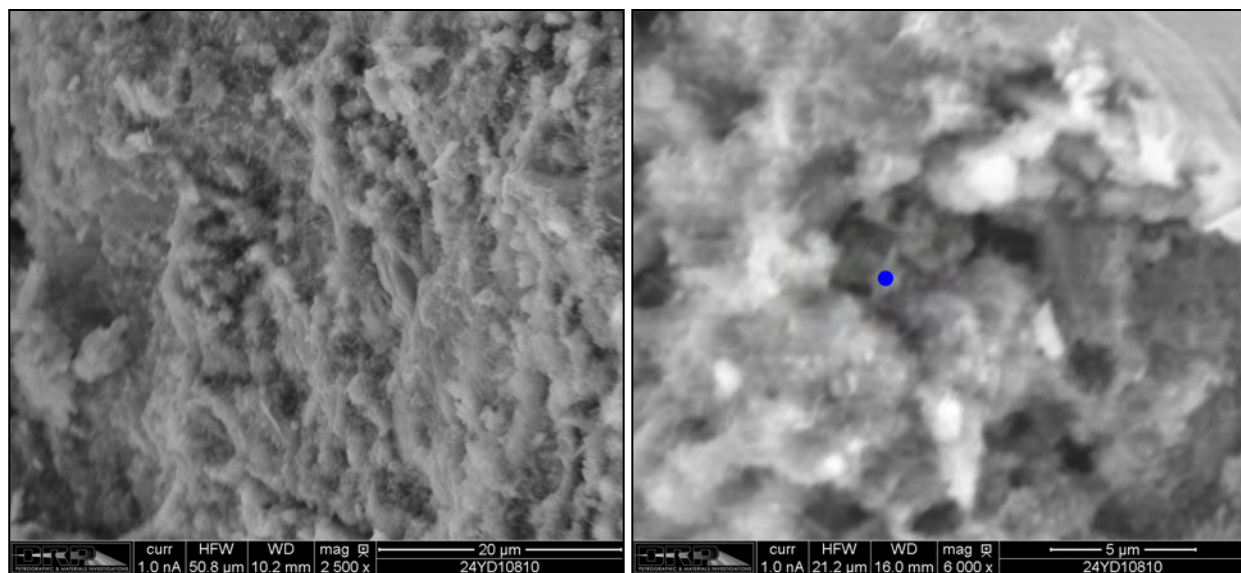
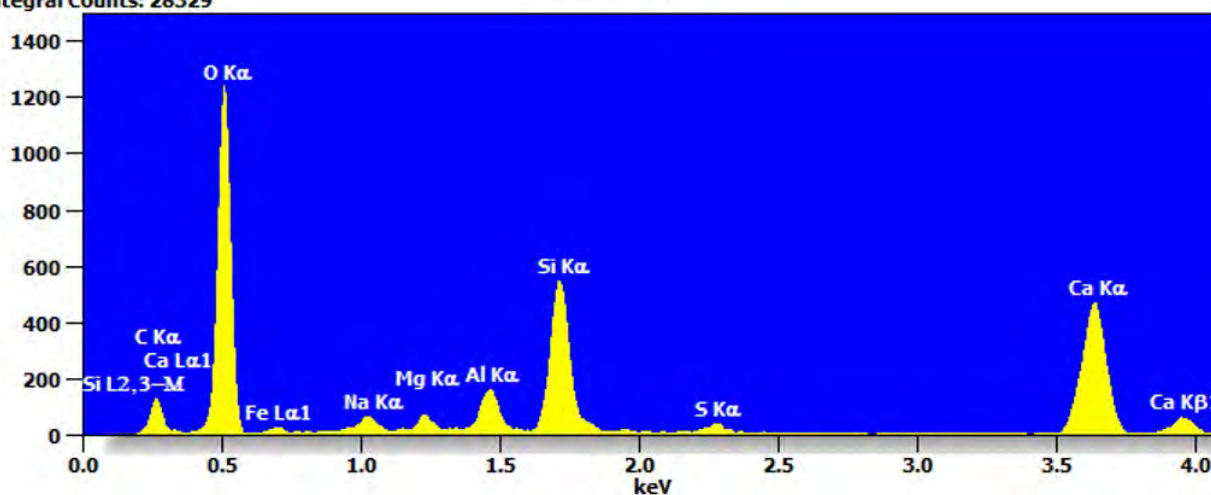
Figure C4. (a) Secondary electron micrograph of a fractured concrete surface at 2500x magnification. (b) Secondary electron micrograph of the same region of fractured surface shown in (a) at 6000x magnification with EDS point analysis location indicated by blue circle. (c) Corresponding spectrum from EDS point analysis shown in (b). Note carbon K α peak at ~0.3 keV, oxygen K α peak at ~0.5 keV, and calcium K α peak at ~3.7 keV.
